APOLLO PROGRAM

FINAL FLIGHT EVALUATION REPORT APOLLO 9 MISSION

JUNE 1969

D2-117017-6
FLIGHT EVALUATION REPORT - APOLLO 9 MISSION

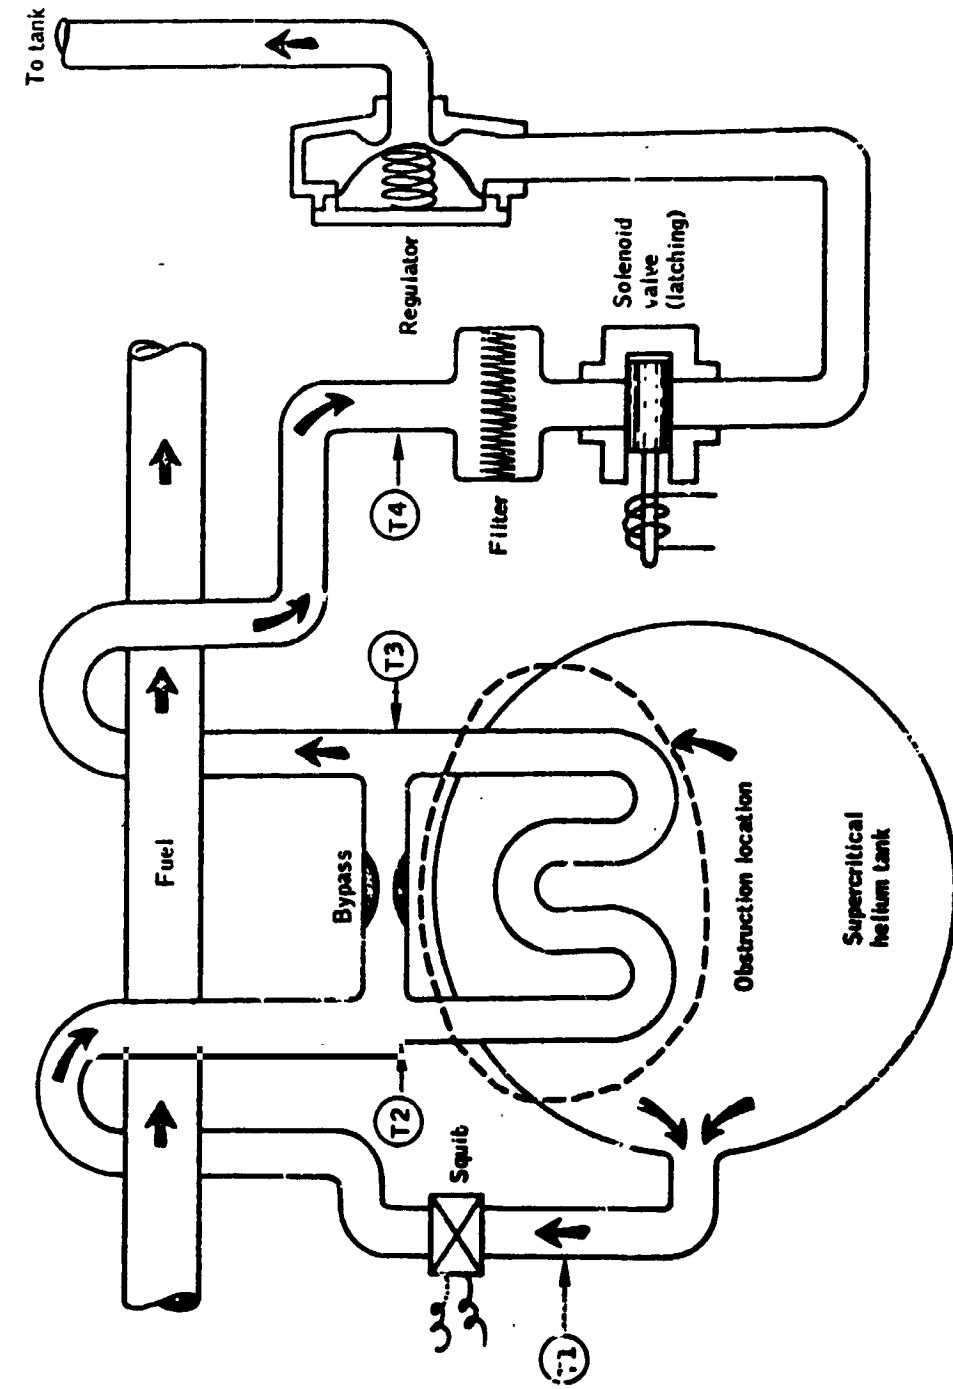
FIG. 2.1.1.22-1 DPS HELIUM REGULATOR

TITLE: DESCENT PROPULSION REGULATOR MANIFOLD PRESSURE DROP

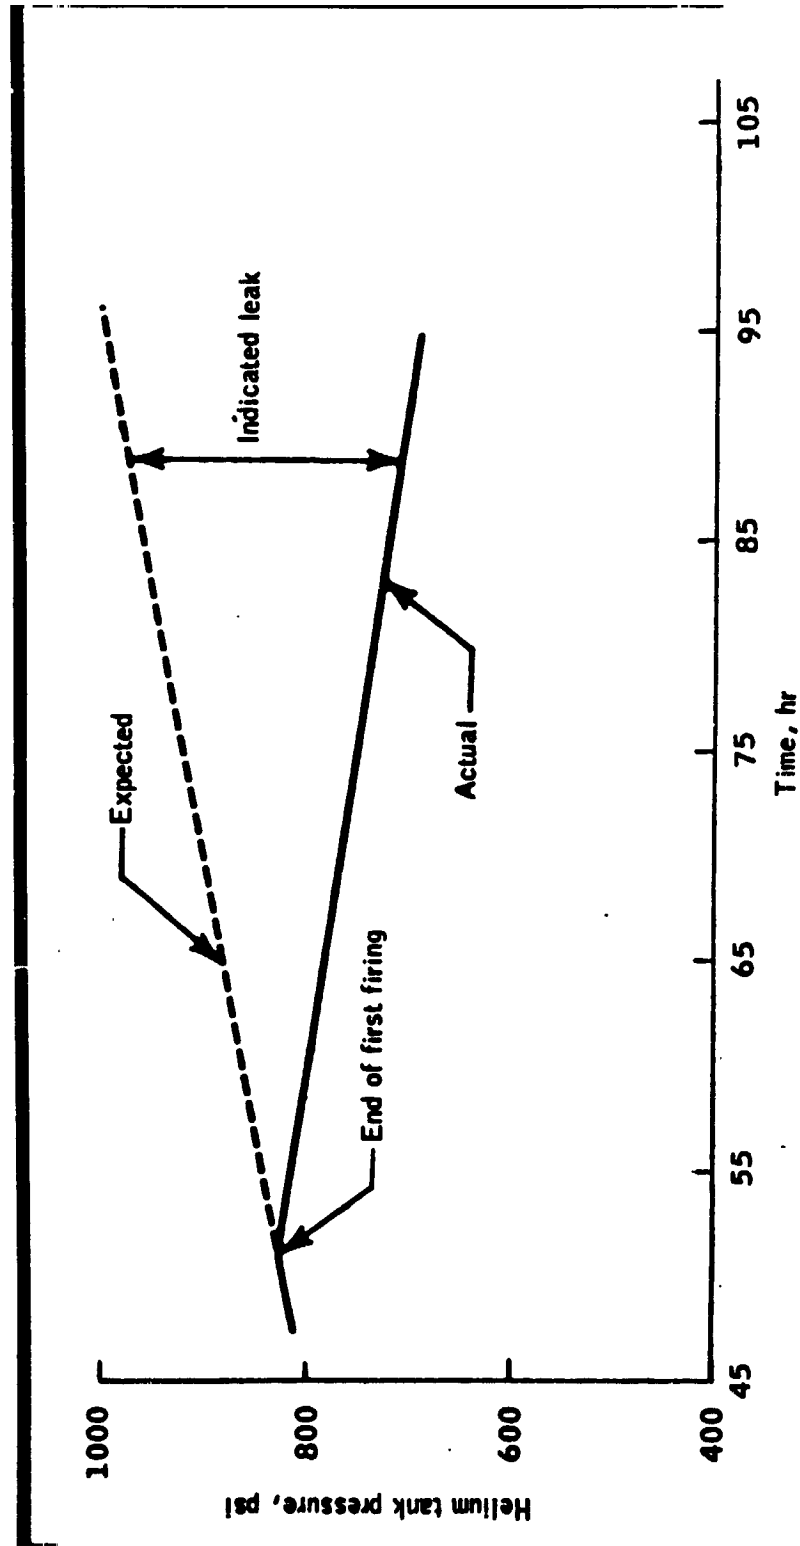
FIG. 2.1.23-1 SUPERCRITICAL HELIUM PRESSURE DECAY

NO. 2.1.1.23	TITLE: SUPERCRITICAL HELIUM PRESSURE DECAY
SYSTEM: LM	MISSION: APOLLO 9
SUBSYSTEM: DPS	EVENT TIME: 70:30
<p>PROBLEM: THE PRESSURE IN THE SUPERCRITICAL HELIUM TANK FOR THE DESCENT PROPULSION SYSTEM BEGAN DECAYING AT 2.9 PSI/HR IMMEDIATELY AFTER SHUTDOWN OF THE FIRST DESCENT ENGINE FIRING AND CONTINUED TO DECAY UNTIL STAGING. BECAUSE OF HEAT TRANSFER INTO THE TANK, THE PRESSURE SHOULD ALWAYS INCREASE UNDER NO-FLOW CONDITIONS. THE PRESSURE DECAY IS INDICATIVE OF A LEAK OF ABOUT 0.1 LB/HR FROM THE HELIUM SYSTEM.</p> <p>THE FLIGHT CONFIGURATION OF HELIUM TANK, SQUIB VALVE, BIMETALLIC FITTING, AND ASSOCIATED PLUMBING HAS NEVER BEEN TESTED TOGETHER FOR RESPONSE TO SQUIB VALVE FIRING SHOCK.</p>	
<p>ACTION: A TEST HAS BEEN MADE ON THE SQUIB VALVE ASSOCIATED PLUMBING HAVE ADEQUATE STRENGTH TO SURVIVE THE EXPECTED FLIGHT ENVIRONMENT FOR APOLLO 10 AND SUBSEQUENT. THE LEAK EXPERIENCED DURING APOLLO 9 WAS PROBABLY CAUSED BY A DEFECTIVE BRAZE THAT WAS INTERNAL TO THE SQUIB VALVE AND COULD NOT BE INSPECTED.</p>

TITLE: SUPERCRITICAL HELIUM PRESSURE DECAY

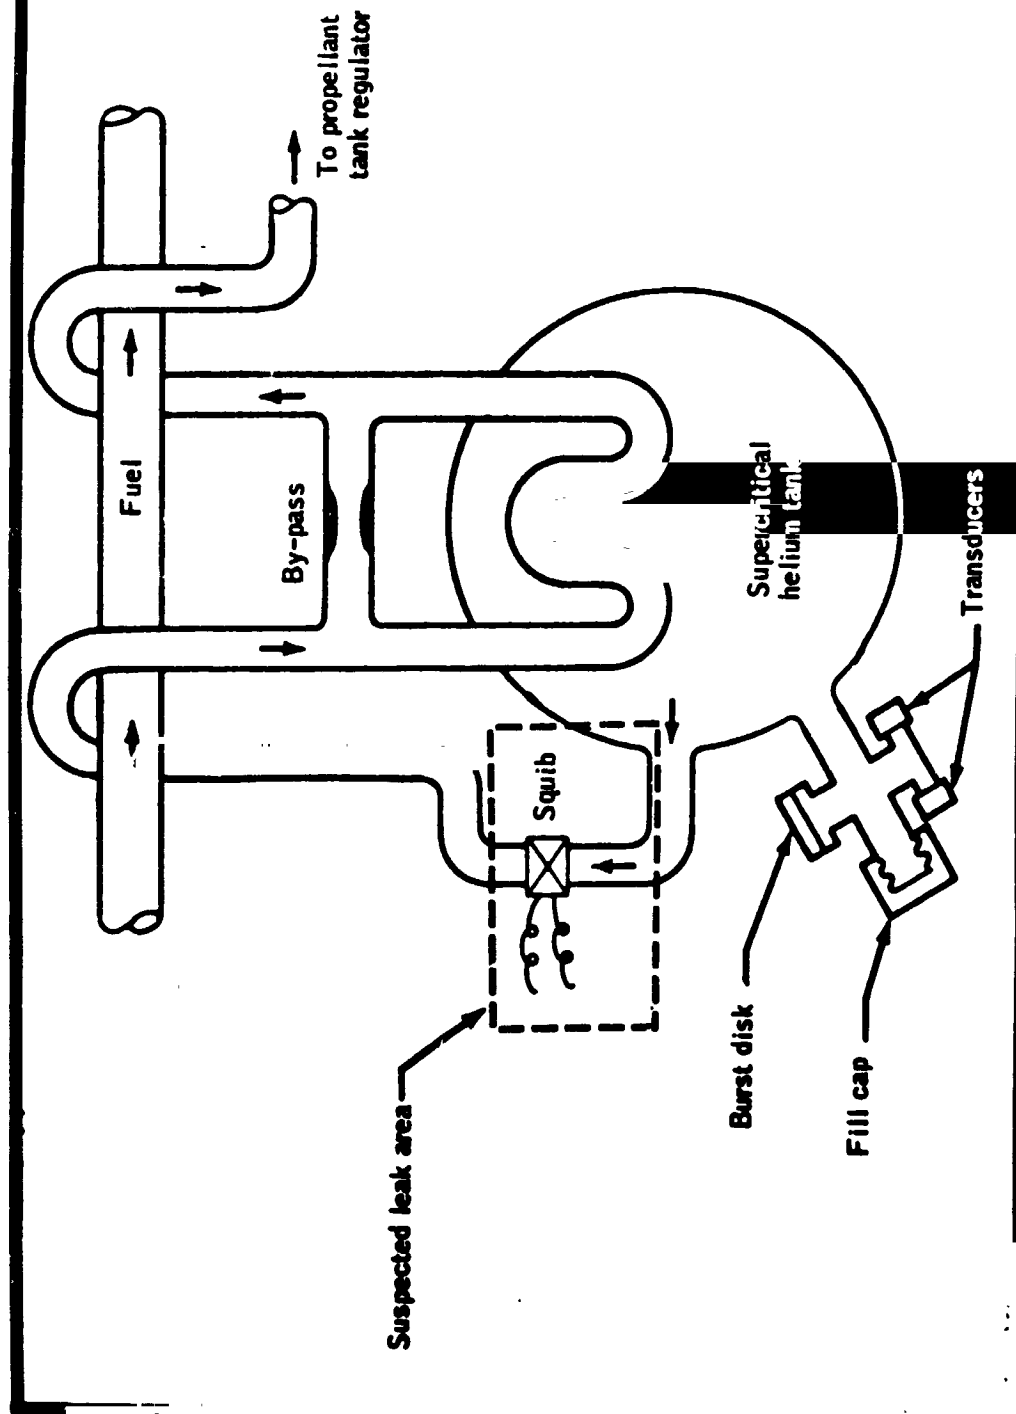
FIG. 2.1.23-2 SUPERCRITICAL HELIUM TANK

TITLE: SUPERCRITICAL HELIUM PRESSURE DECAY

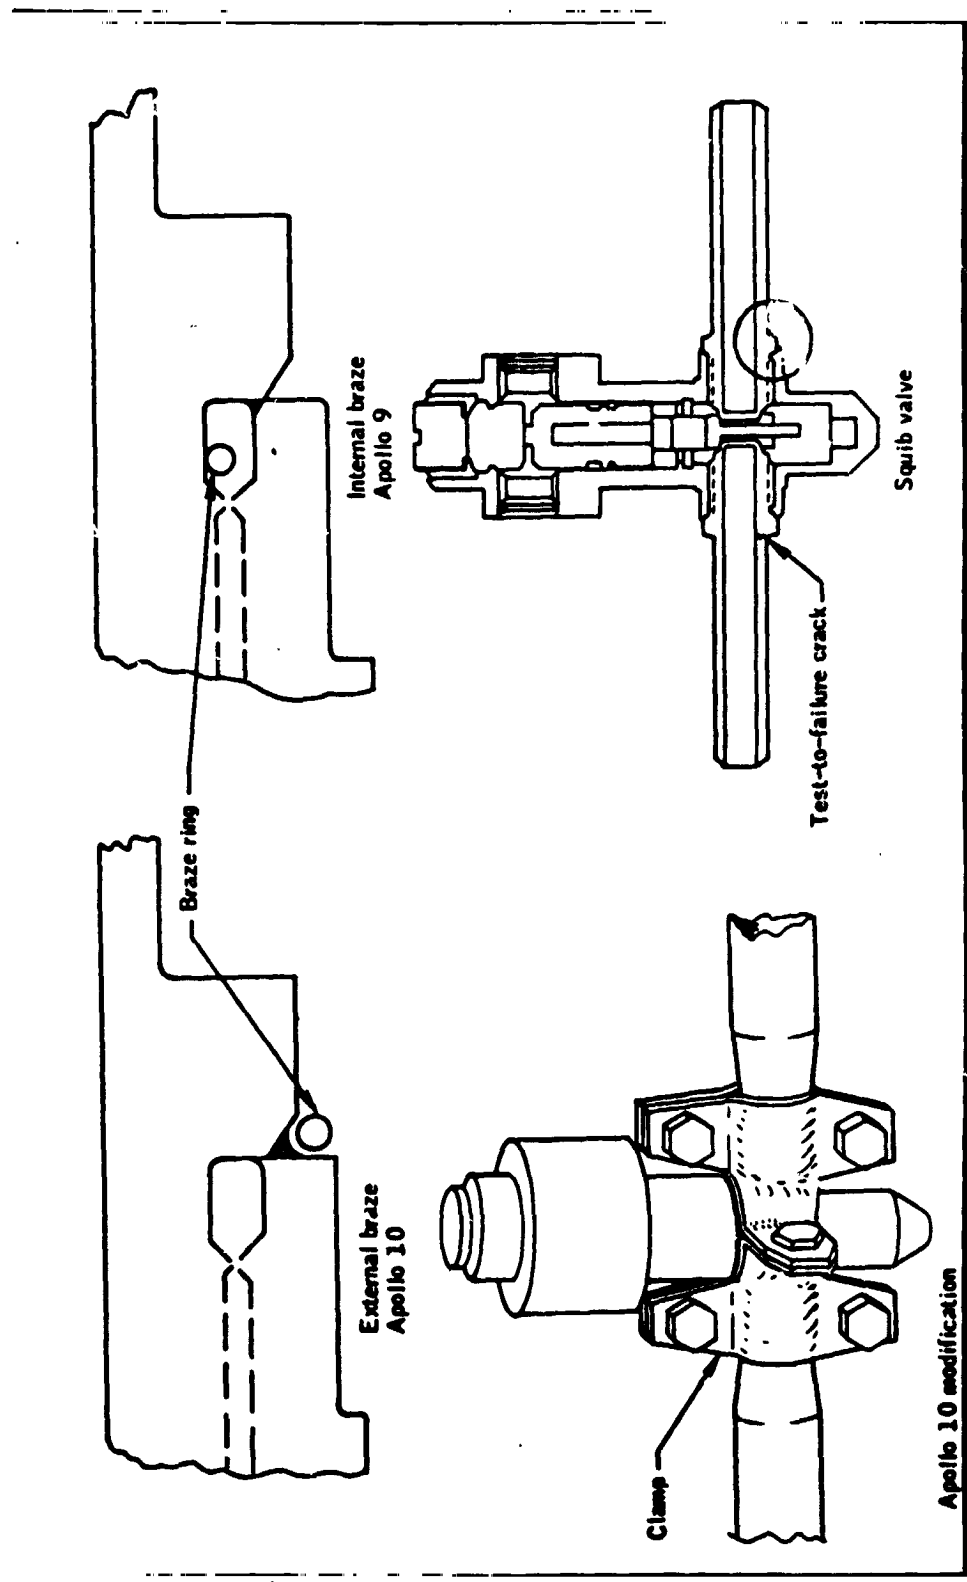
FIG. 2.1.23-3 SQUIB VALVE

TITLE: SUPERCRITICAL HELIUM PRESSURE DECAY

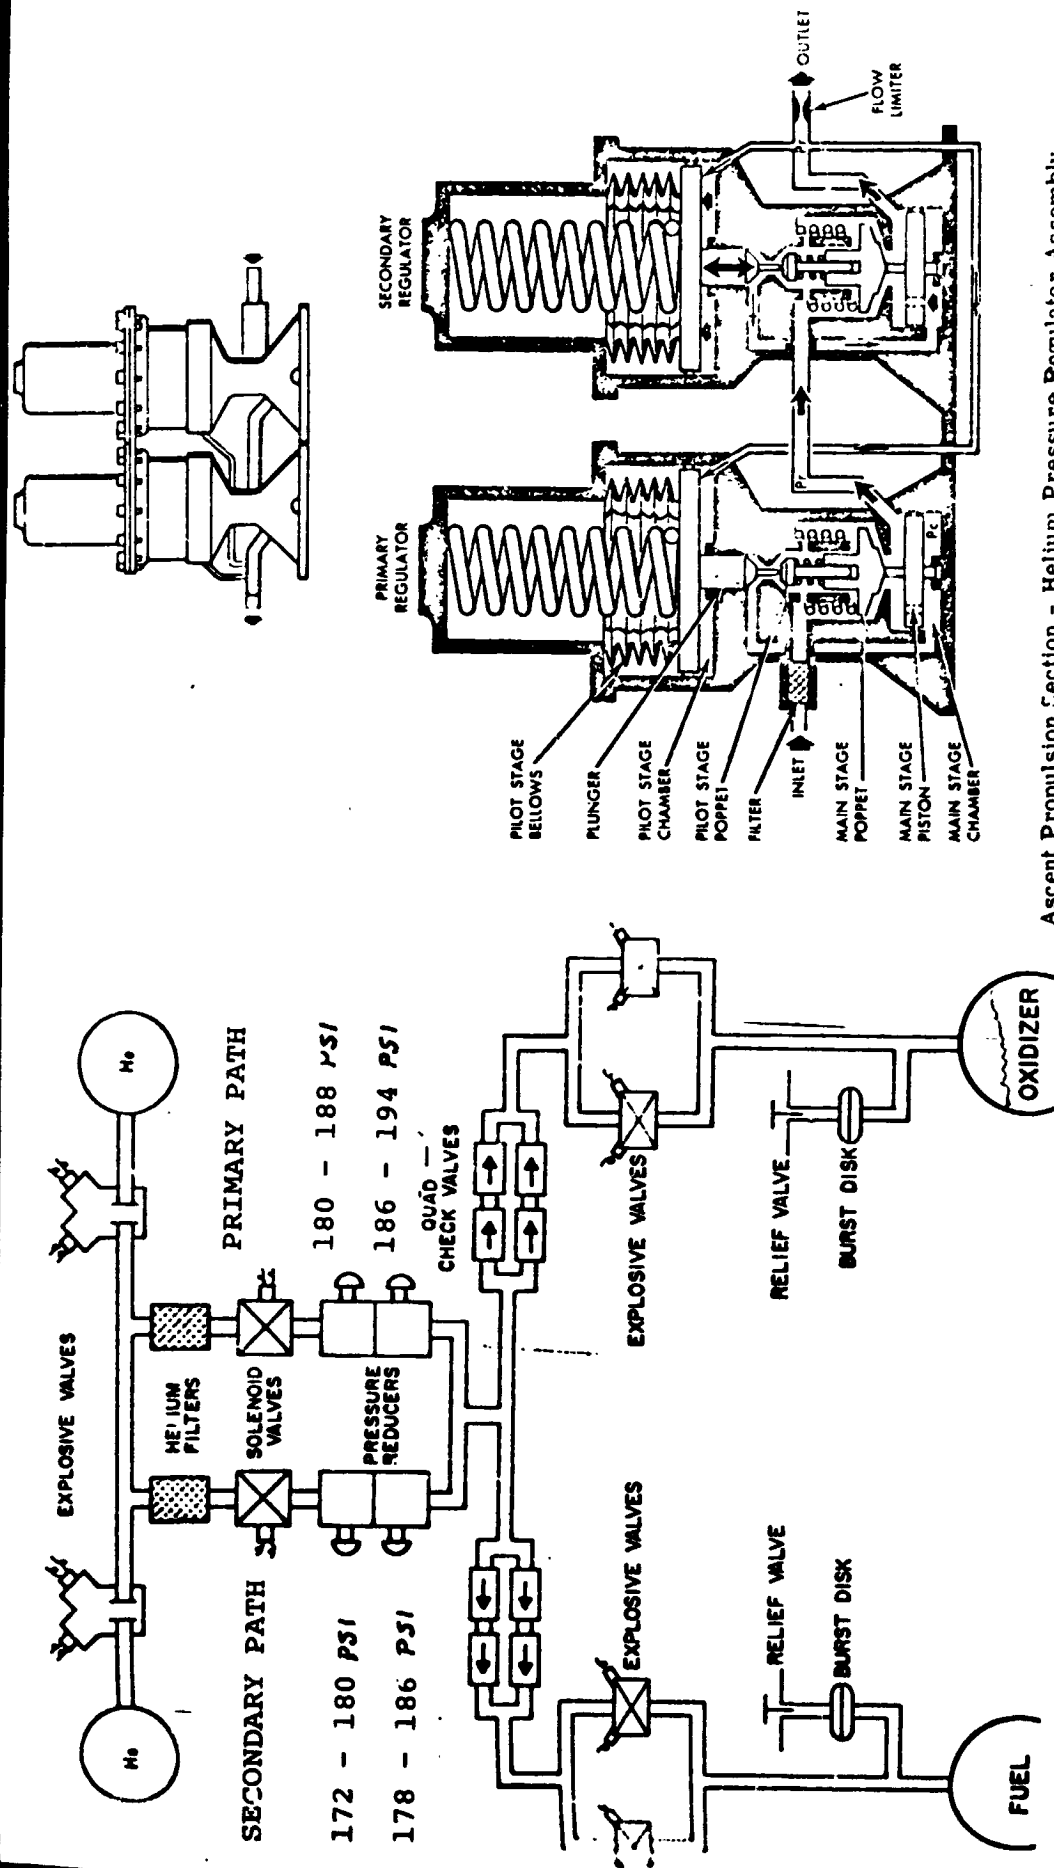
FIG. 2.1.25-1 APS REGULATOR DIAGRAM

TITLE: ASCENT PROPULSION SYSTEM REGULATOR LEG BLOCKAGE

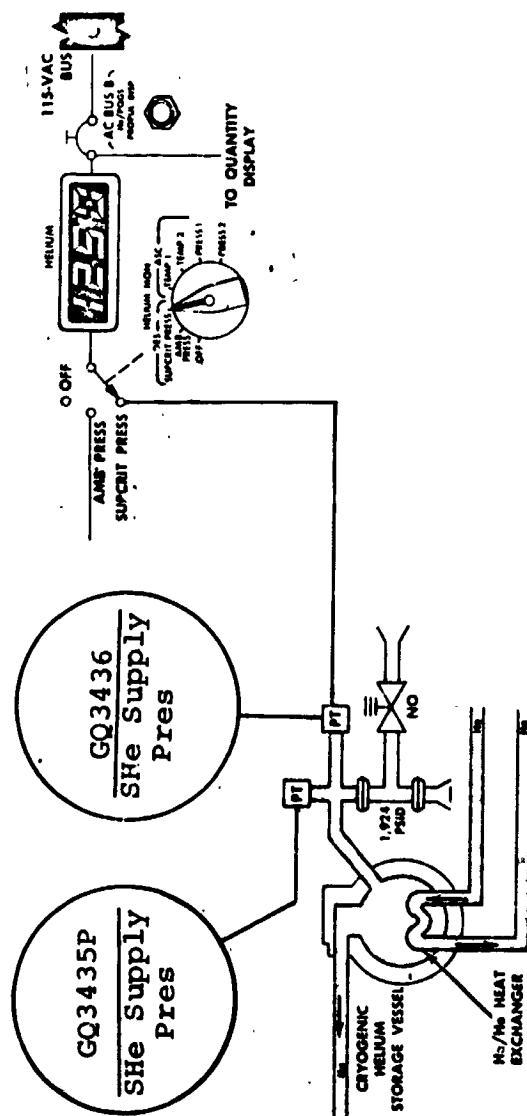
FIG. 2.1.28-1 SUPERCRITICAL HELIUM PRESSURE INSTRUMENTATION

TITLE: SUPERCRITICAL HELIUM PRESSURE INSTRUMENTATION

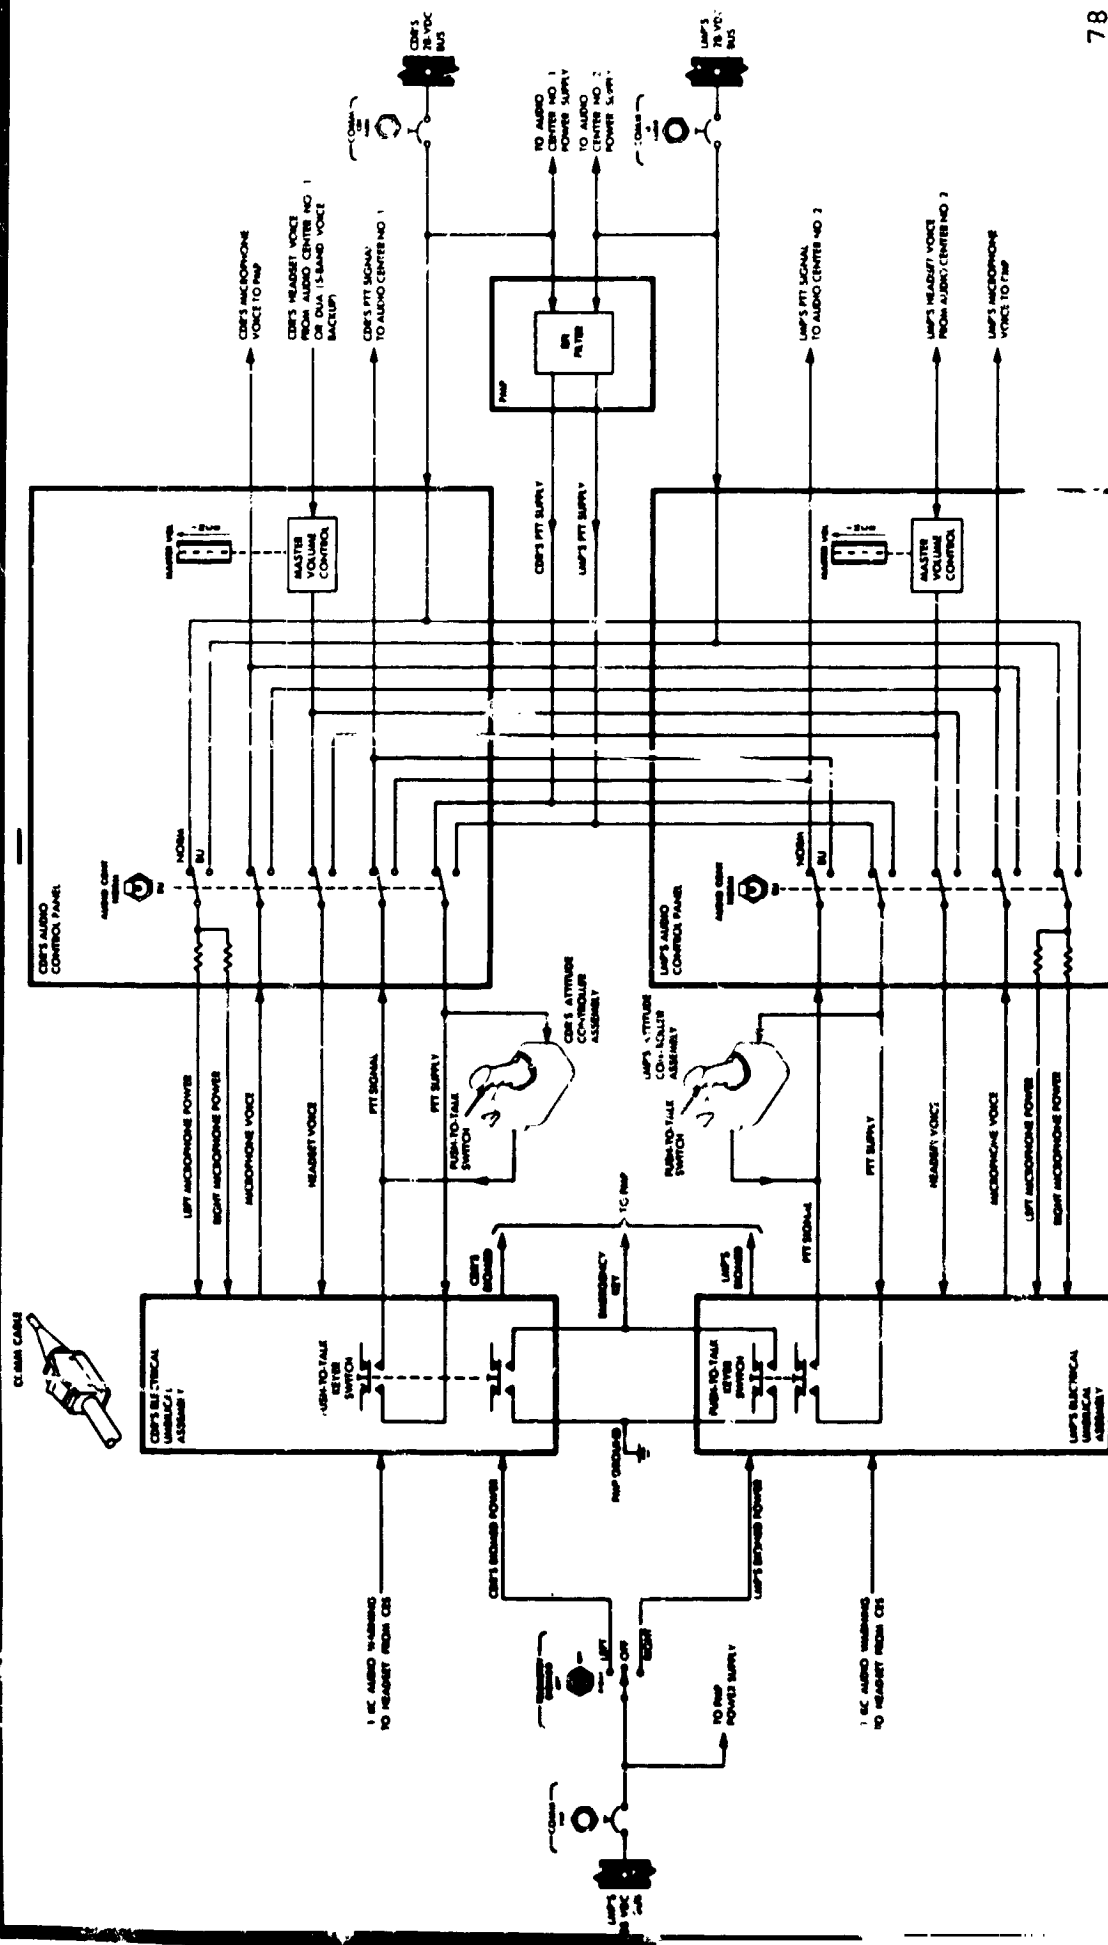
FIG. 2.1.33-1 **PUSH-TO-TALK SWITCH DIAGRAM**

TITLE: PUSH-TO-TALK SWITCHES INOPERATIVE

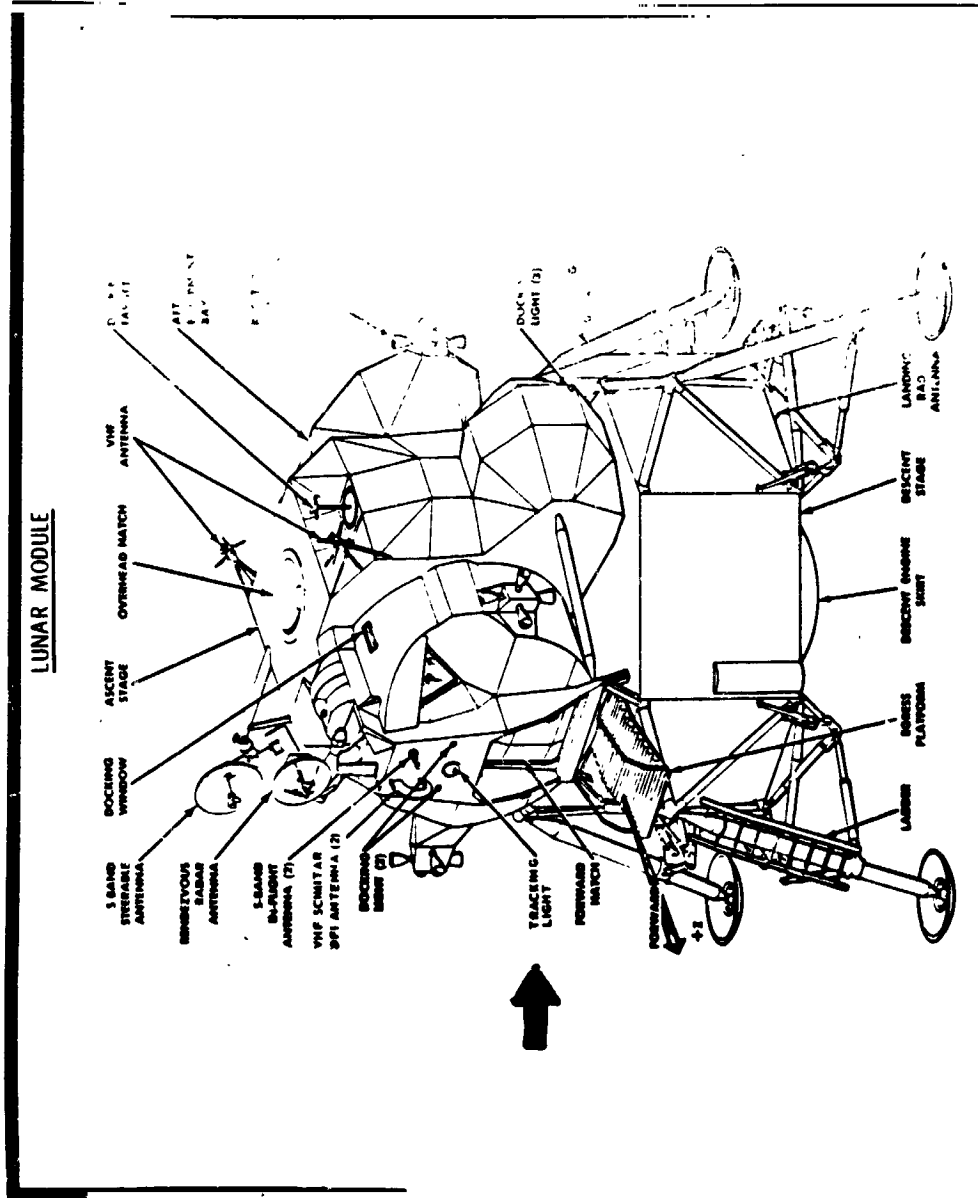
FIG. 2.1.34-1 LUNAR MODULE

TITLE: TRACKING LIGHT FAILURE

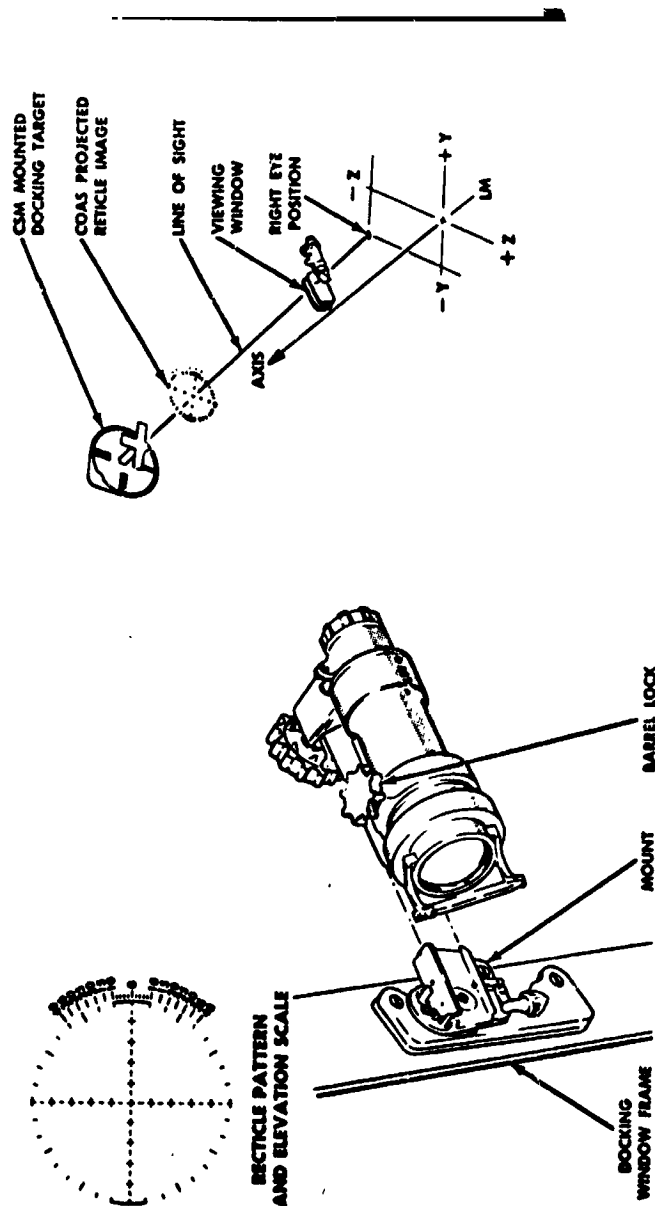
FIG. 2.1.35-1

TITLE: LIGHTING FOR CREW OPTICAL ALIGNMENT SIGHT

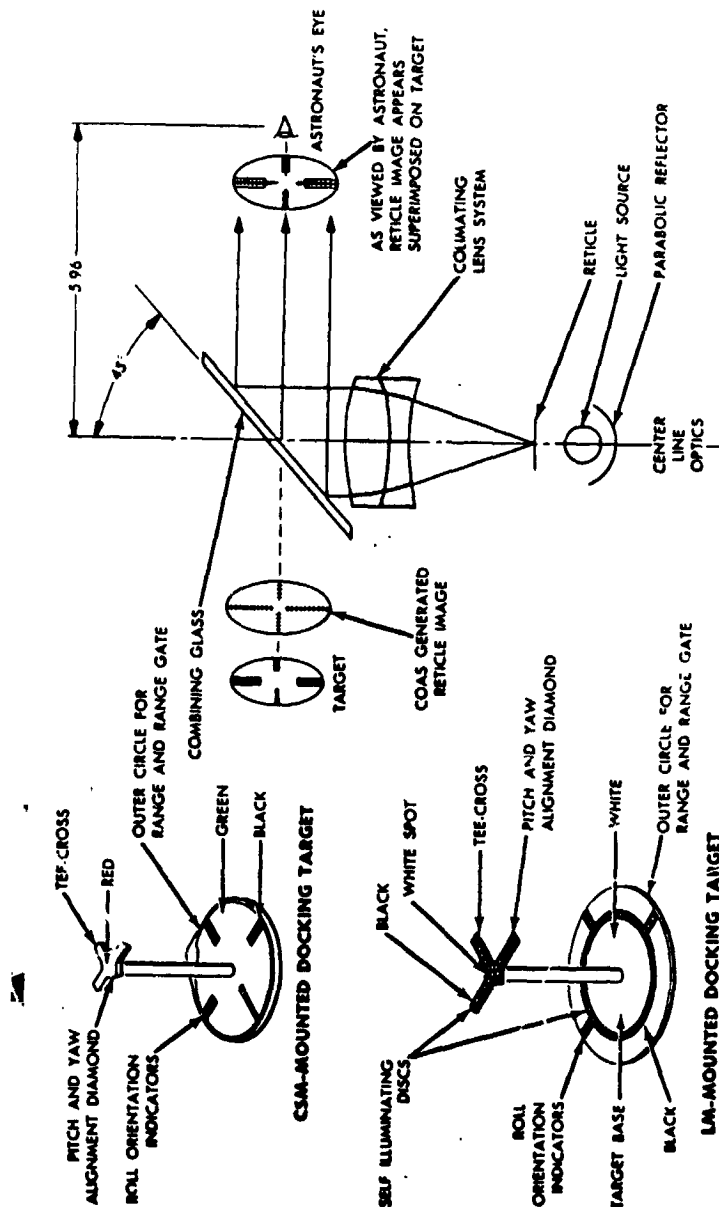
FIG. 2.1.35-2 OPTICAL PATH DETAILS

TITLE: LIGHTING FOR CREW OPTICAL ALIGNMENT SIGHT

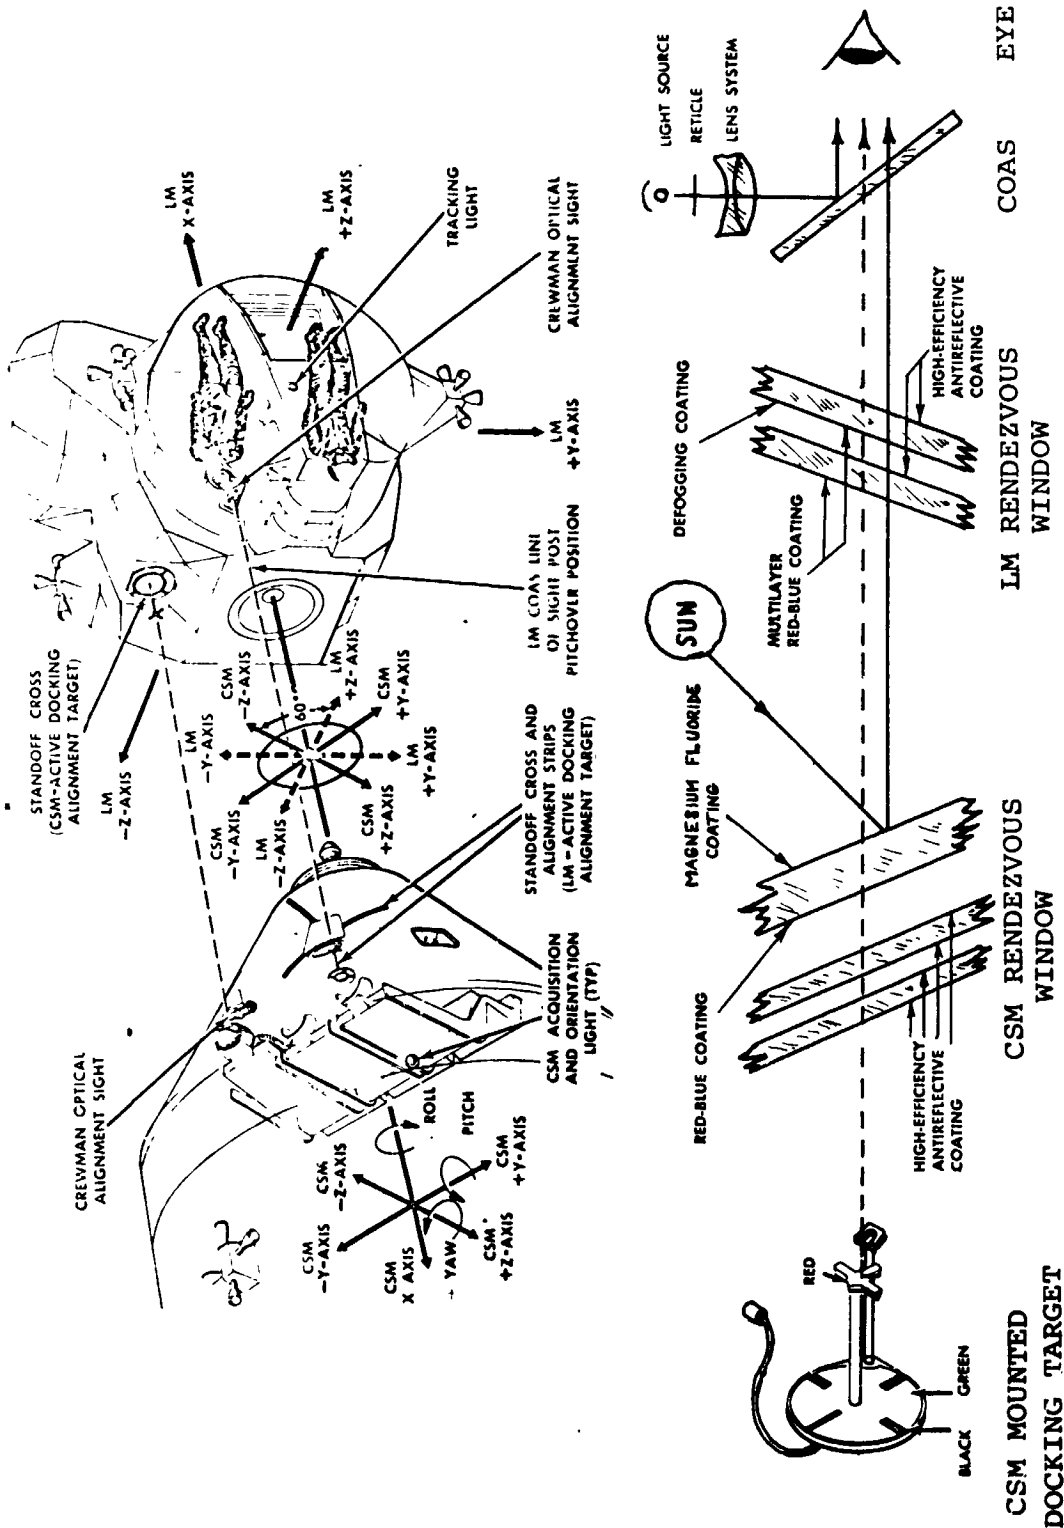
FIG. 2.1.35-3 OPTICAL PATH DETAILS

TITLE: LIGHTING FOR CREW OPTICAL ALIGNMENT SIGHT

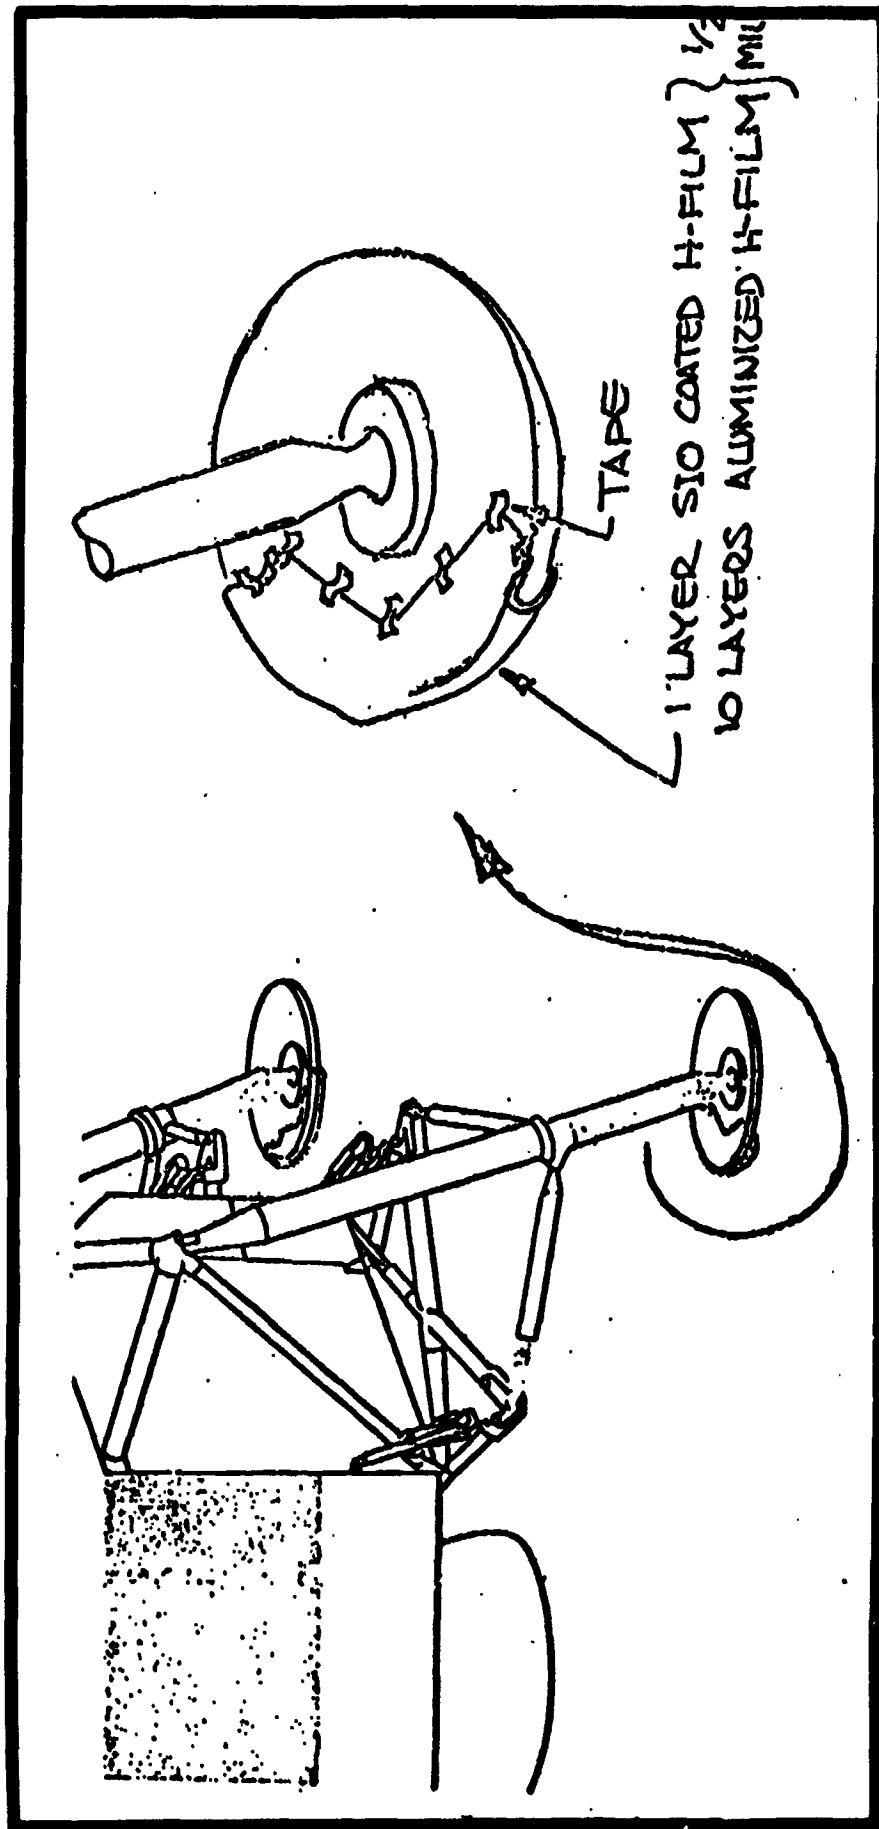
FIG. 2.1.36-1

TITLE: LOOSE PARTICLES DURING DPS BURN

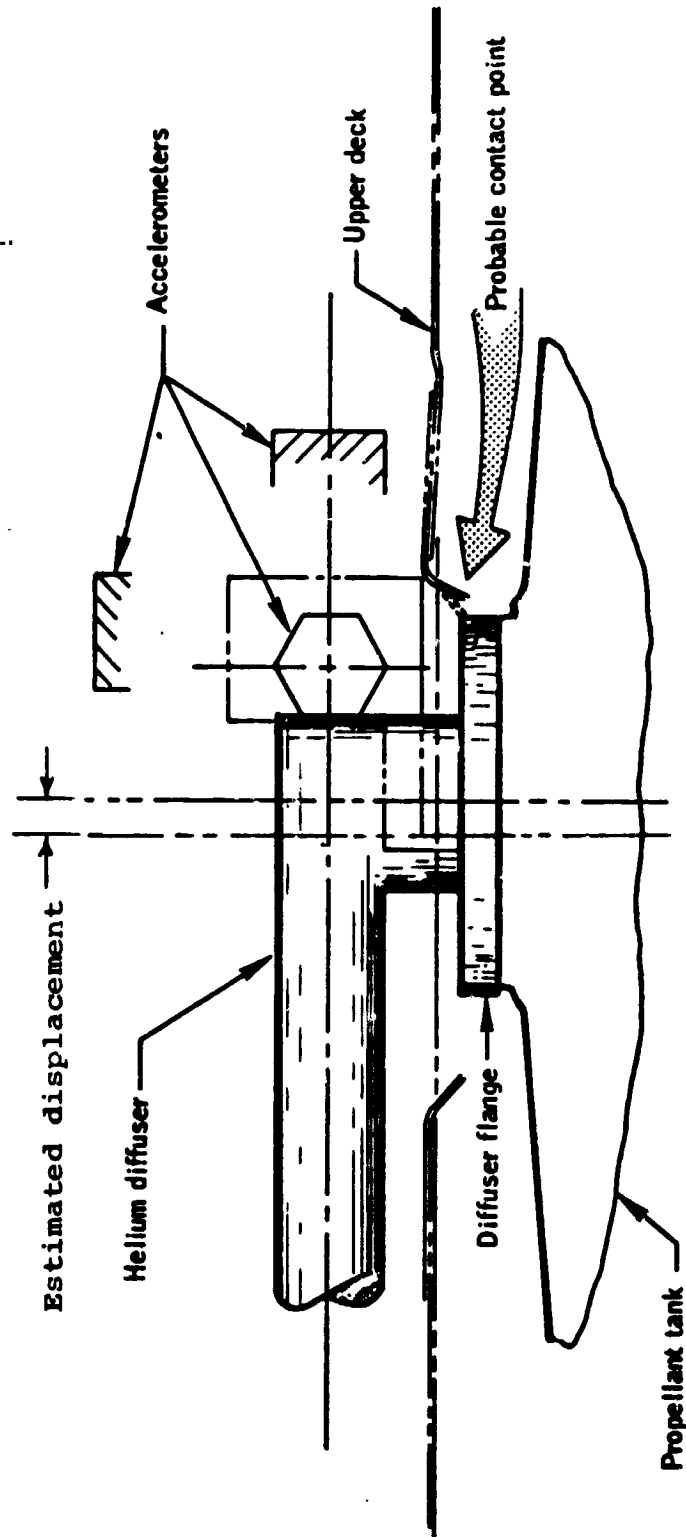
FIG. 2.1.38-1 PROBABLE TANK-TO-UPPER-DECK CONTACT POINT

TITLE: STRUCTURAL CONTACT AT S-IC SHUTDOWN

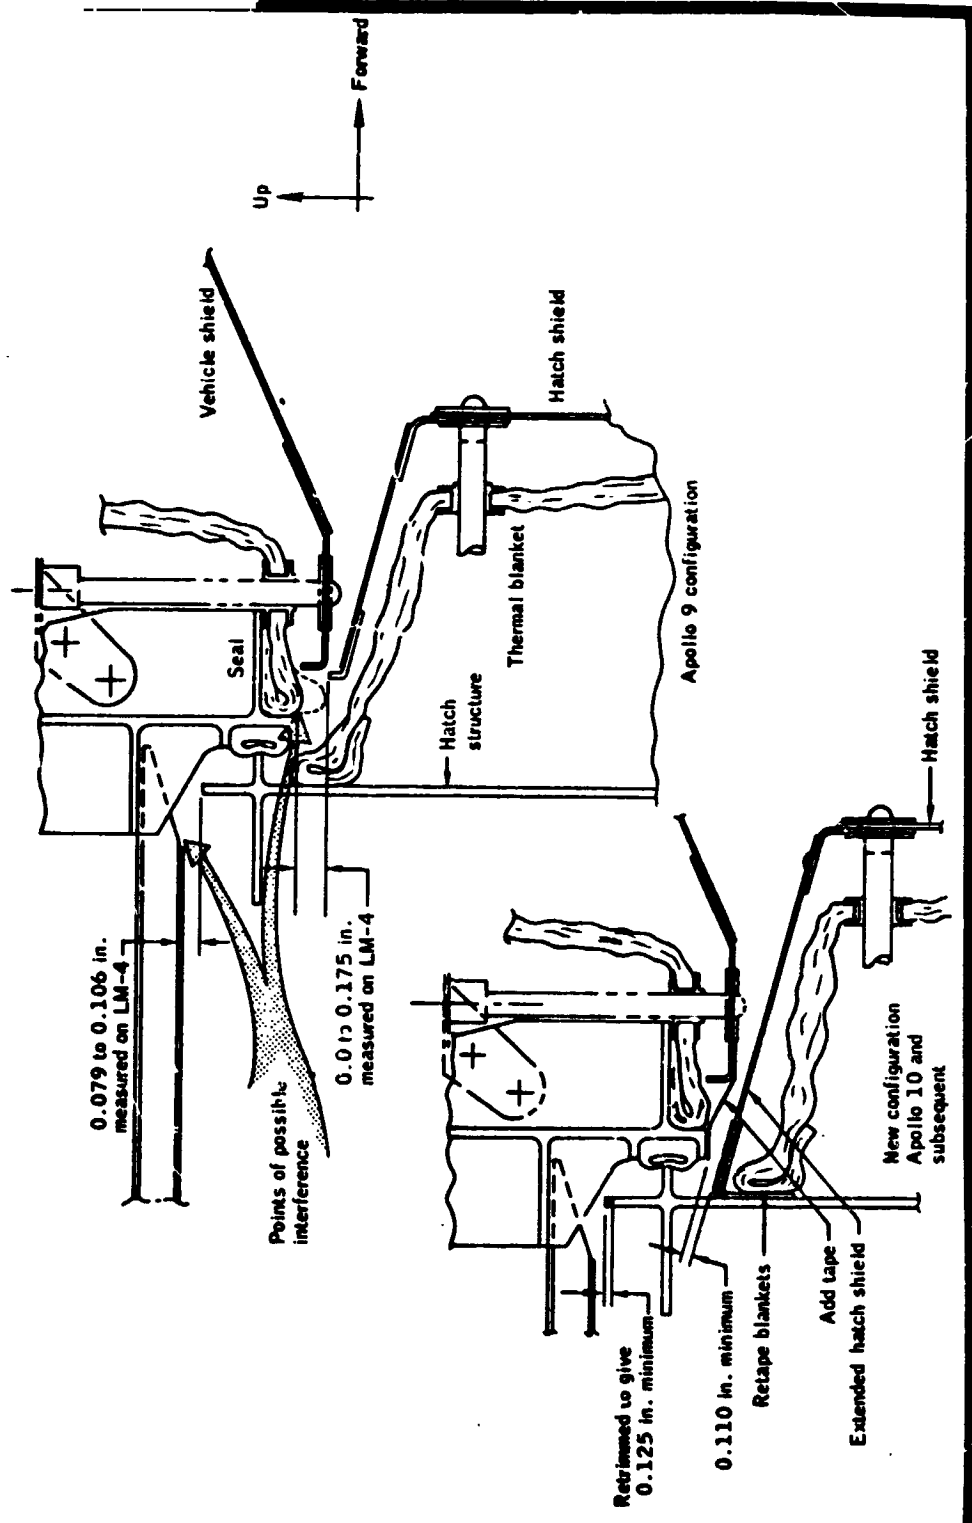
FIG. 2.1.39-1 POTENTIAL HATCH INTERFERENCE

TITLE: BIND OF FORWARD HATCH AND FAILURE OF DOOR STOP

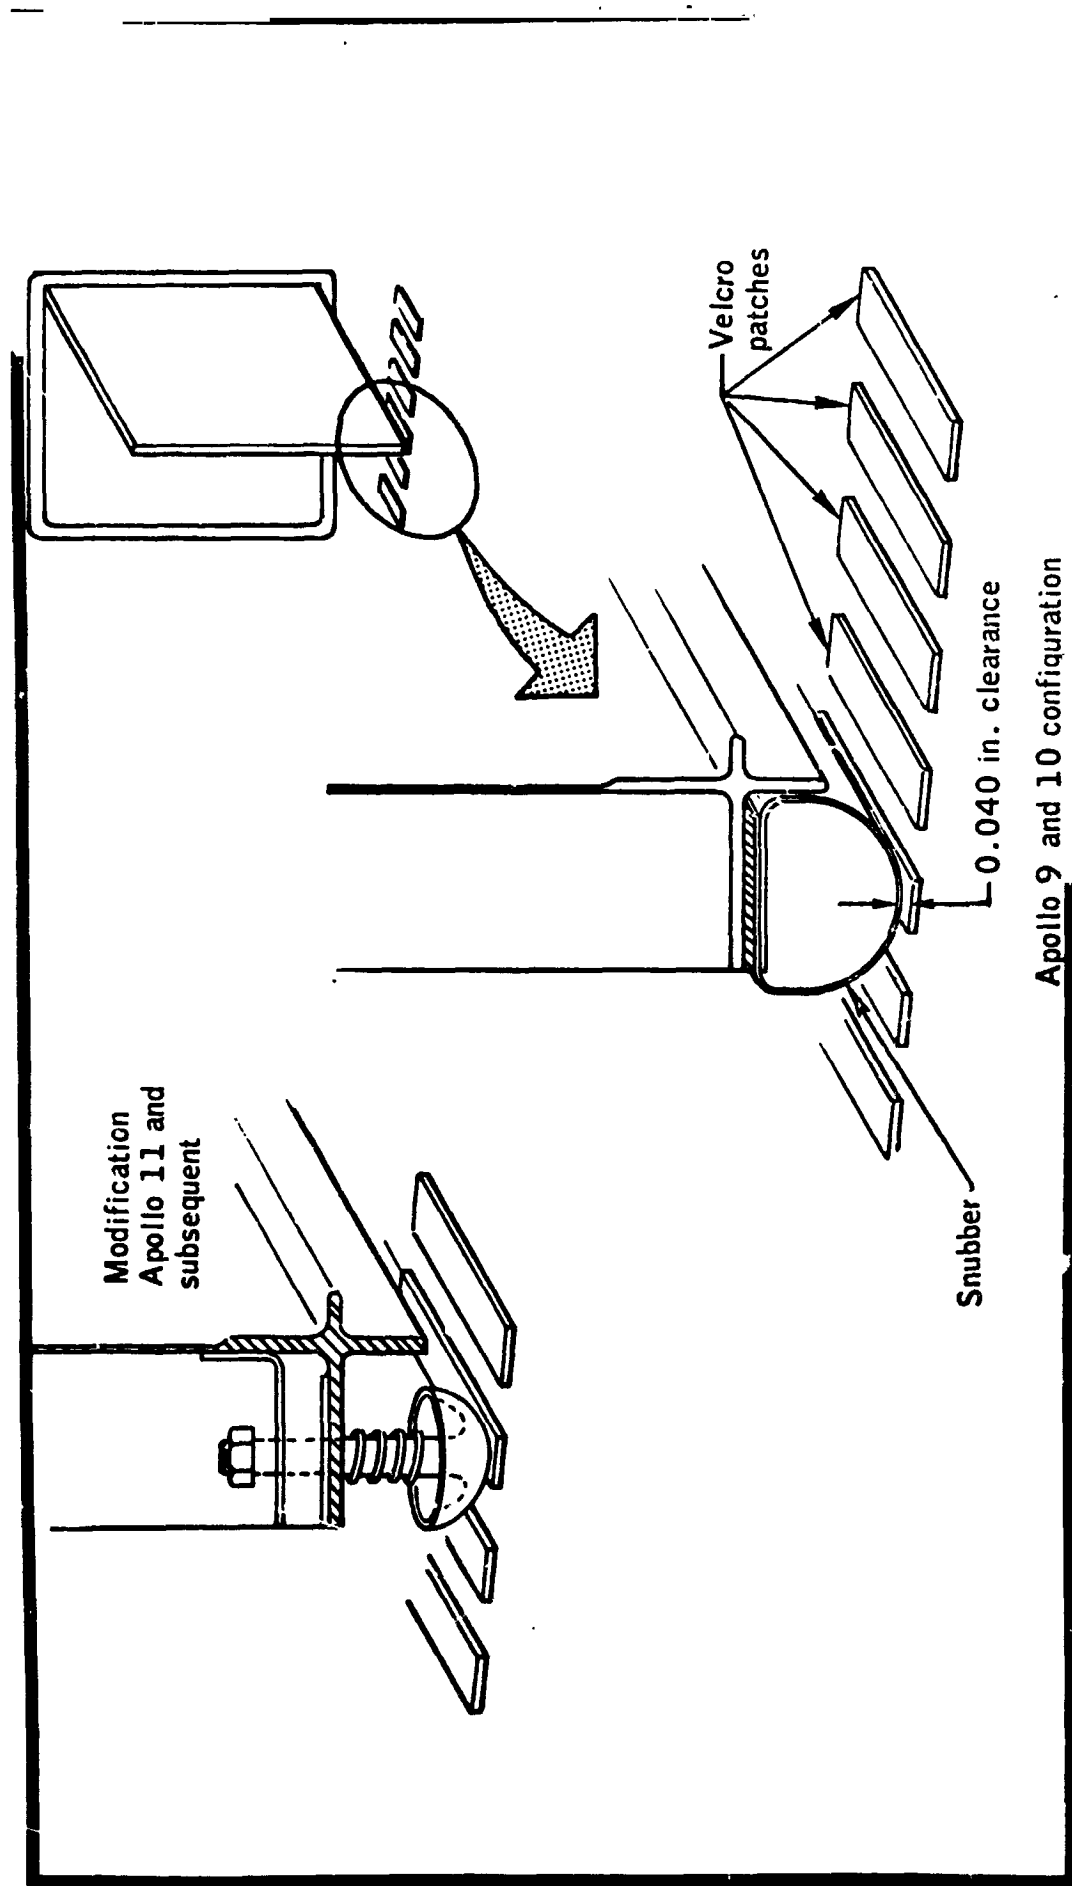
FIG. 2.1.39-2 FORWARD HATCH SNUBBER

TITLE: BINDING OF FORWARD HATCH AND FAILURE OF DOOR STOP

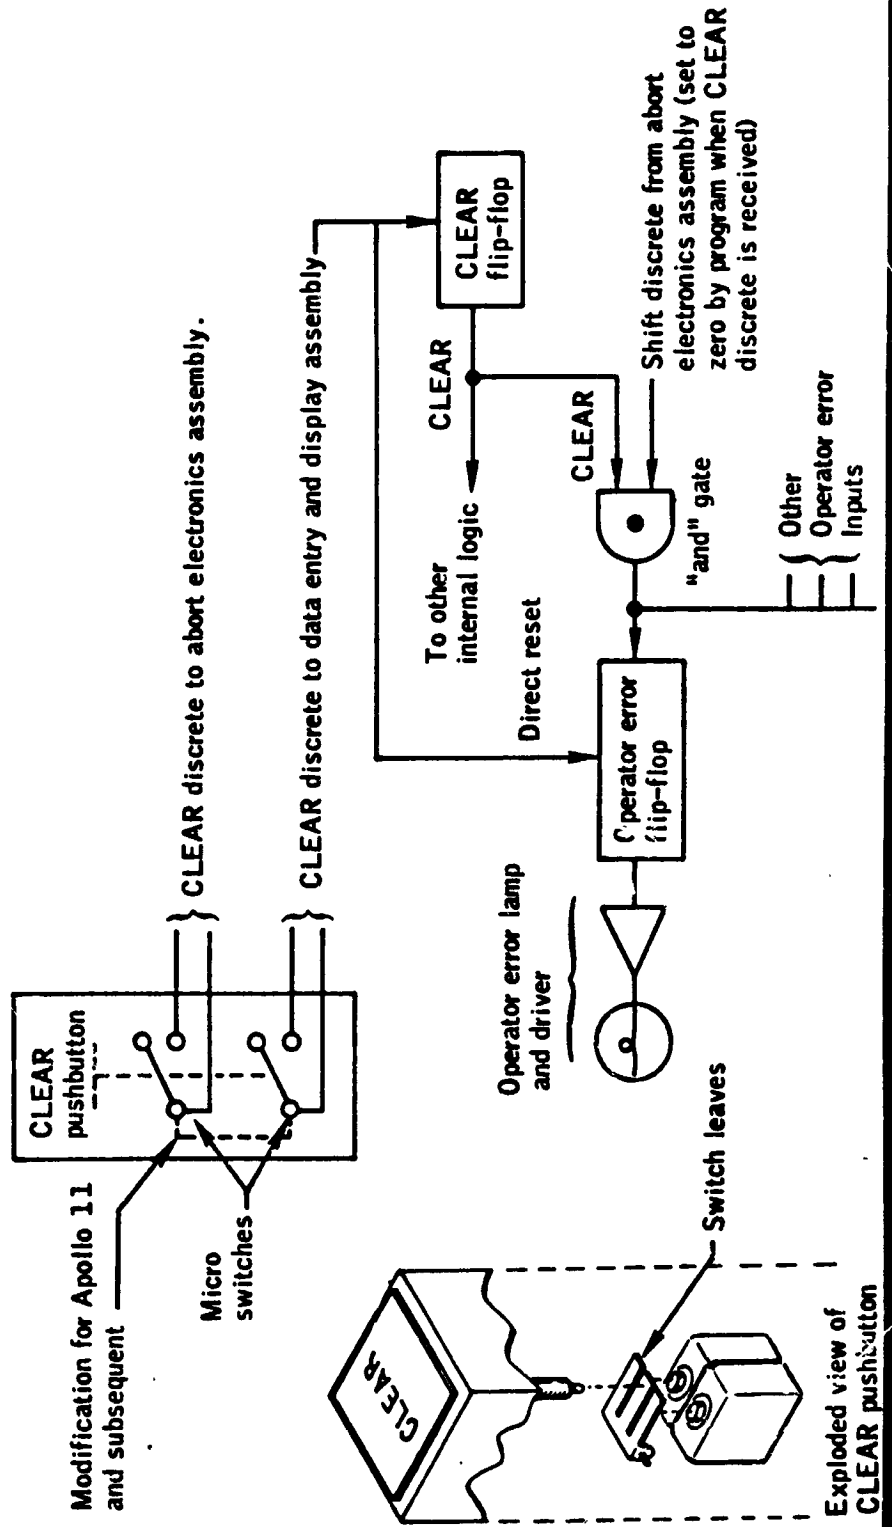
FIG. 2.1.40-1 Simplified data entry and display assembly operator error light circuit.

TITLE: DATA ENTRY AND DISPLAY ASSEMBLY OPERATOR ERROR LIGHT
